Proceedings of the 39th Conference on
OUR WORLD IN CONCRETE & STRUCTURES
20-22 August 2014, Singapore

EVALUATION RESULT ON LONG-TERM PERFORMANCE OF INORGANIC REPAIRING MATERIAL FOR CONCRETE CANAL

Keywords: Repairing material, Concrete canal, Surface covering method, Long-term performance

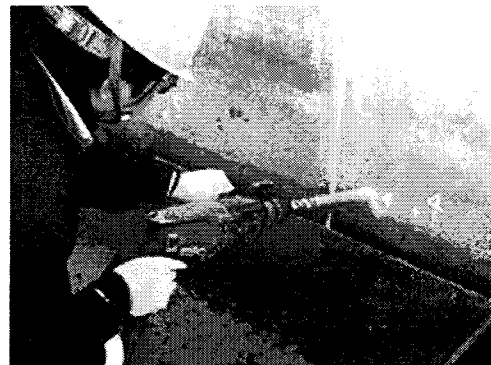
Picture 3: Shaving hole by drill

In this experiment, measurement of neutralization was carried out with digging a diagonal hole to the sidewall of drainage concrete canal by drill shown in Picture 3, and PP solution was sprayed. Diagonal hole made the measurement of boundary between discolored and non-discolored zone easier than right angle hole. Abstract of this method is described in Figure 2. Position of measurement is shown in Figure 3. Totally 7 points were measured; 6 points at right bank of canal's sidewall and one point at the centre of canal's bottom.

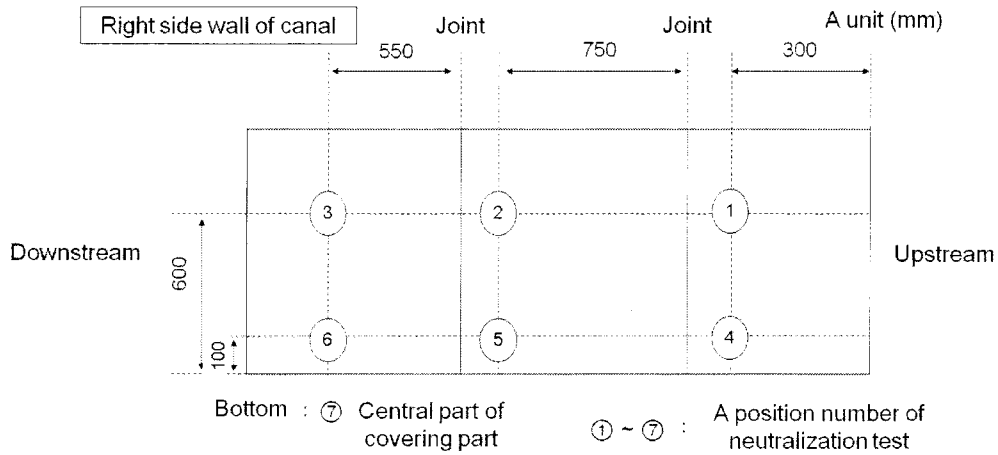
Figure 3: Measurement point of neutralization depth in concrete canal

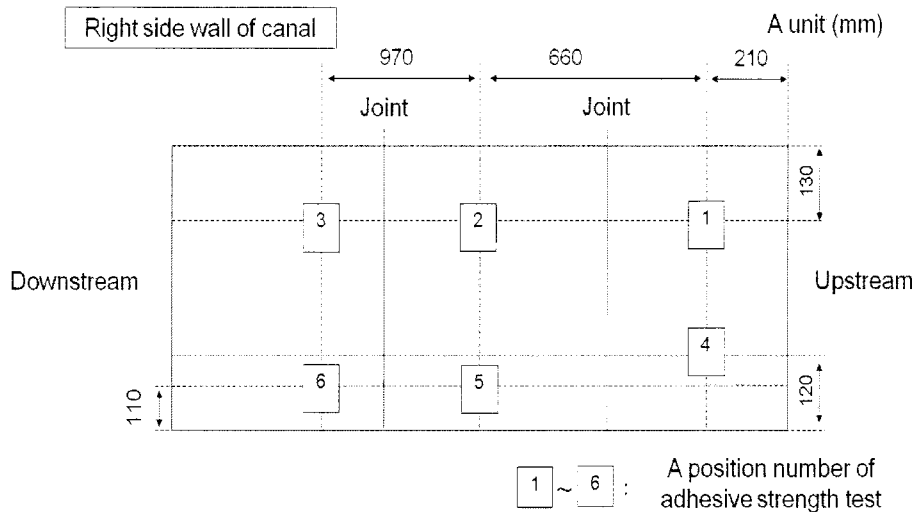
Figure 4: Measurement position of adhesive strength test in concrete canal

measurement point of adhesive strength in this canal was shown in Figure 4. Total points measured in this study were 6. All data were measured at right bank of canal's sidewall, 3 were upper part and 3 were lower part of sidewall. At first, the attachment was pasted using epoxy resin. After hardening, all the side of attachment was cut by the concrete cutter, and measured the adhesive strength.
